PBY Catalina

Walk Around Number 5
squadron/signal publications

By William Scarborough
Color by Don Greer
Illustrated by Joe Sewell

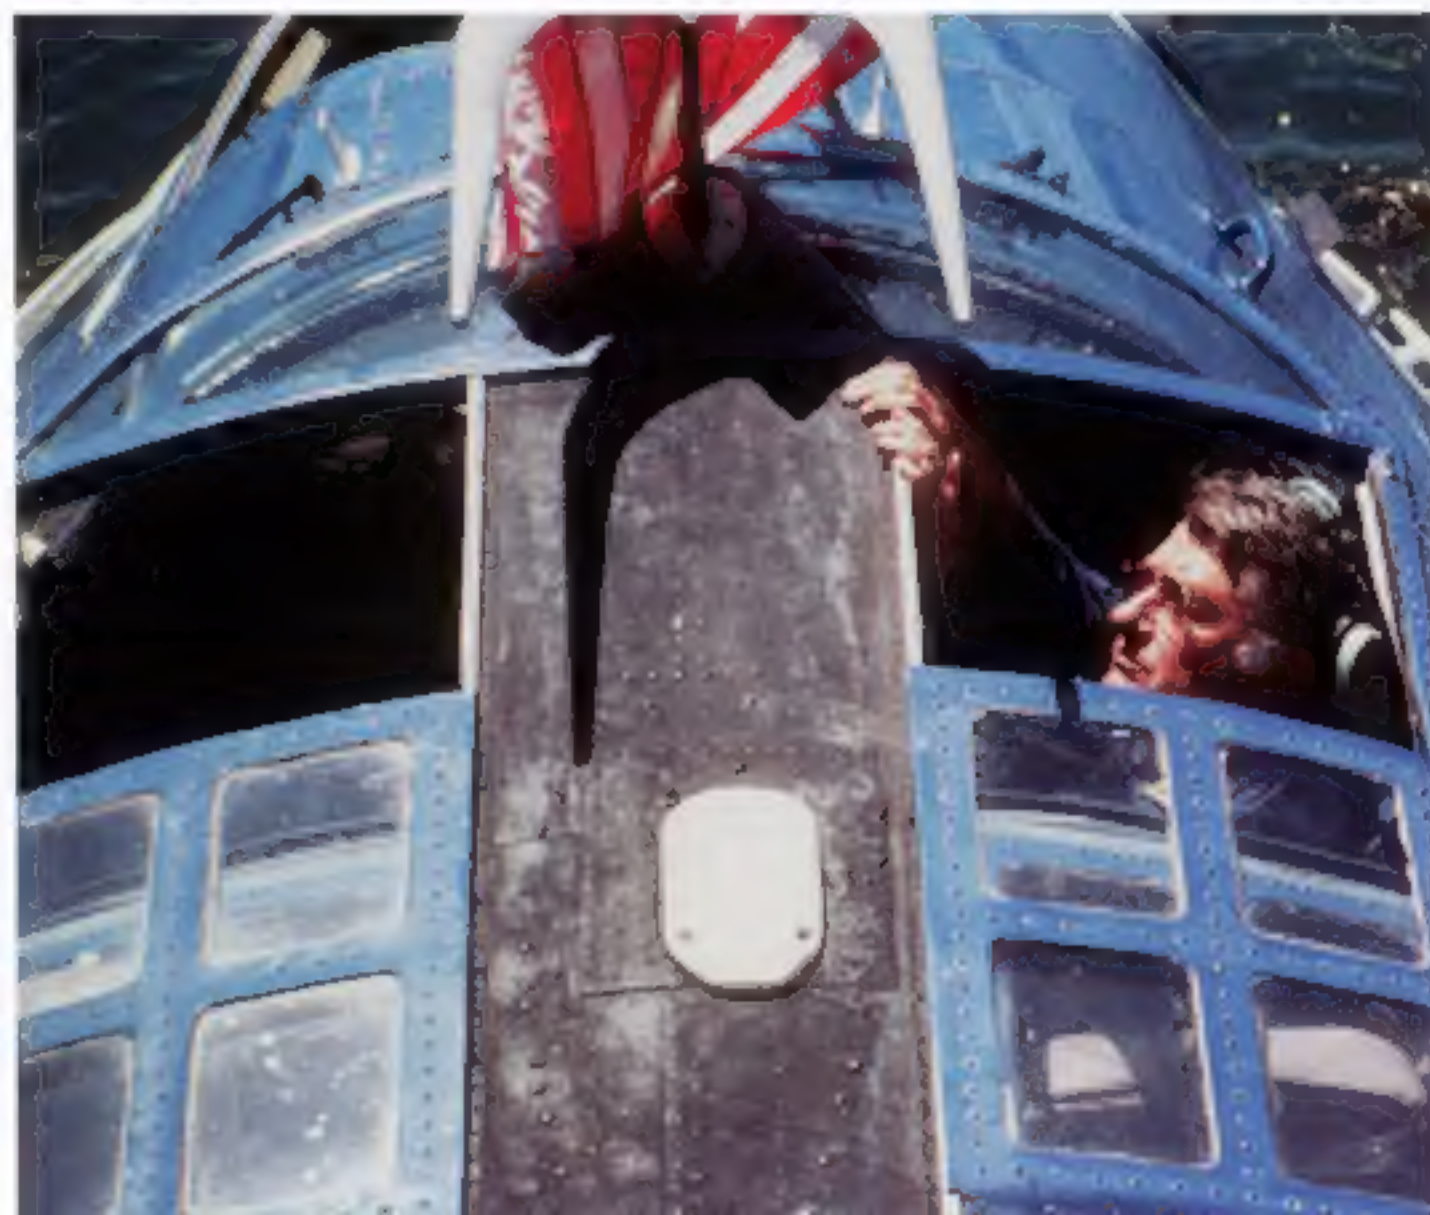
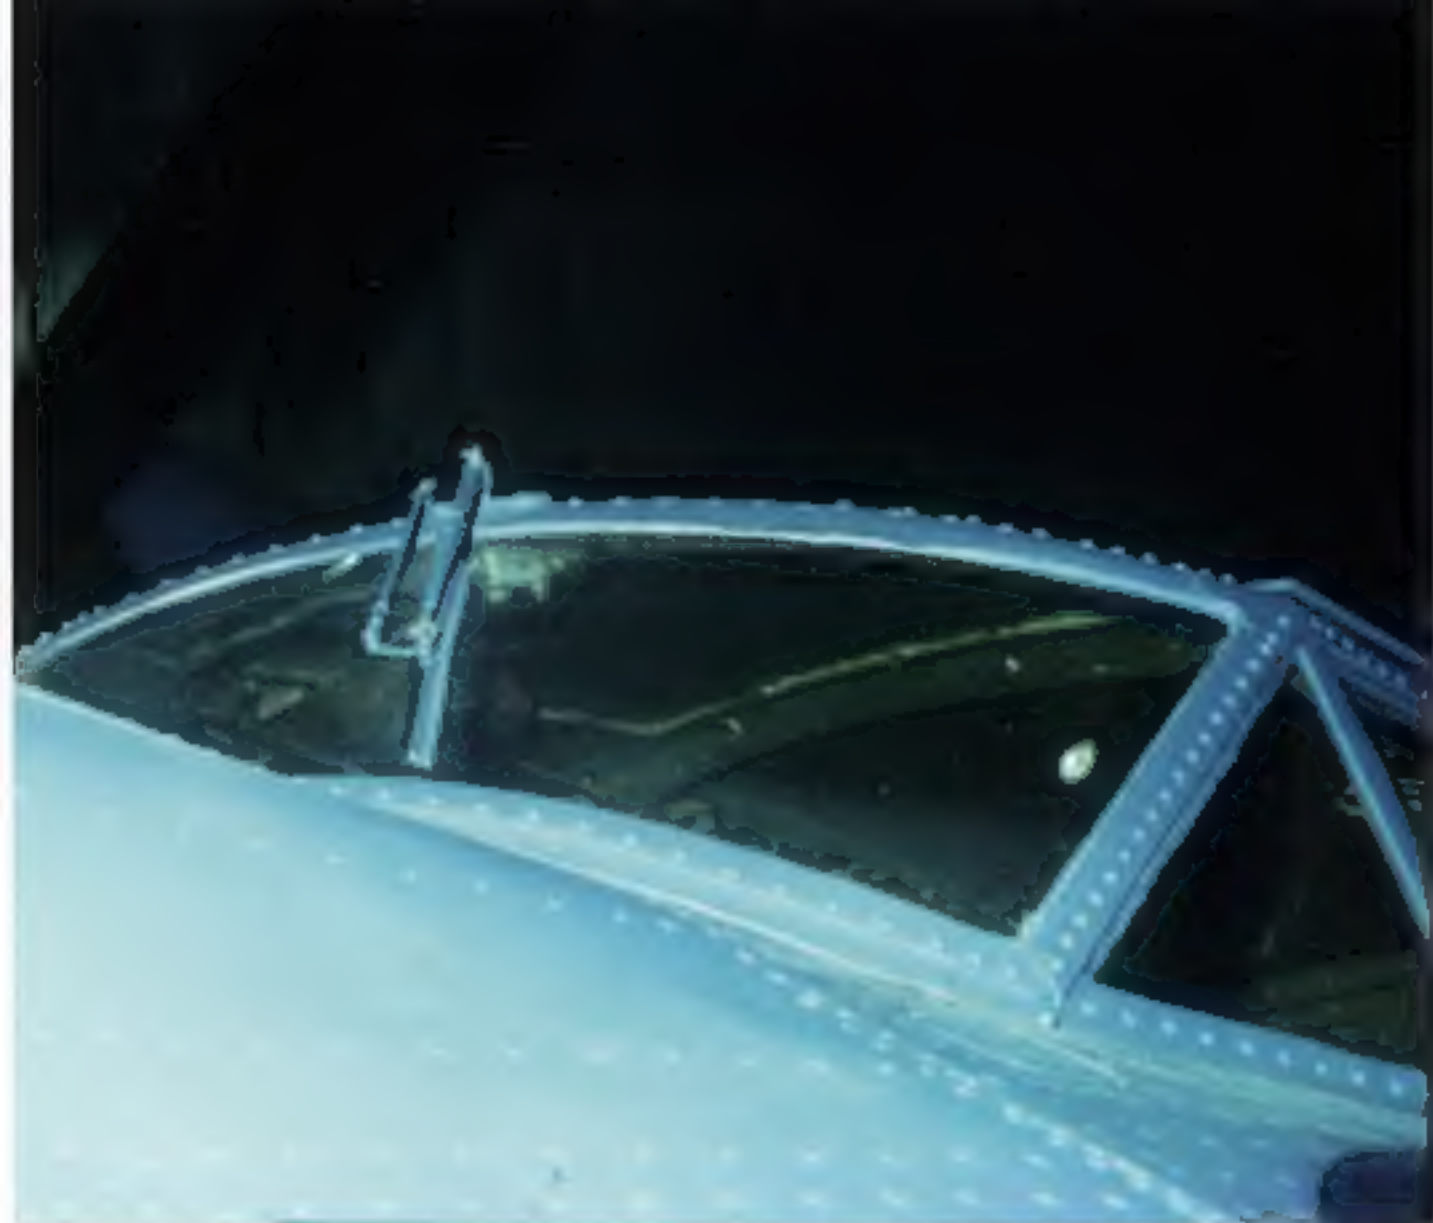
The windshield of the PB-4Y was curved and equipped with wind shield wipers to help remove rain, ice and the sea spray during water operations, (T. Tullis)

The port side window just behind the cockpit was located in the radio operator/navigator station.. (Mike Aldrich)

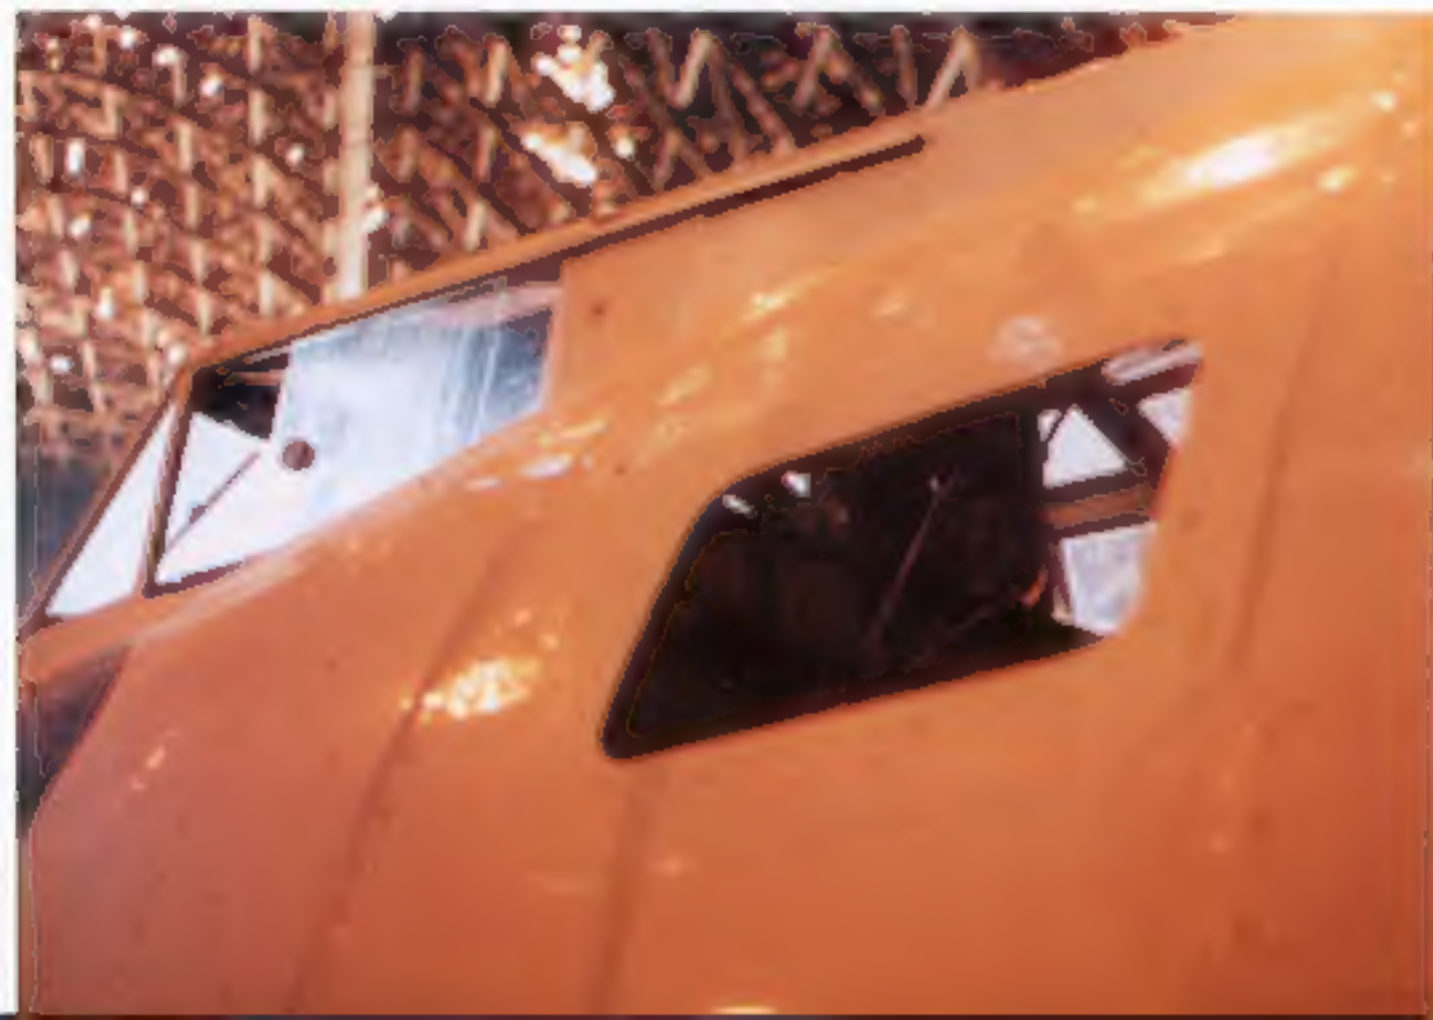
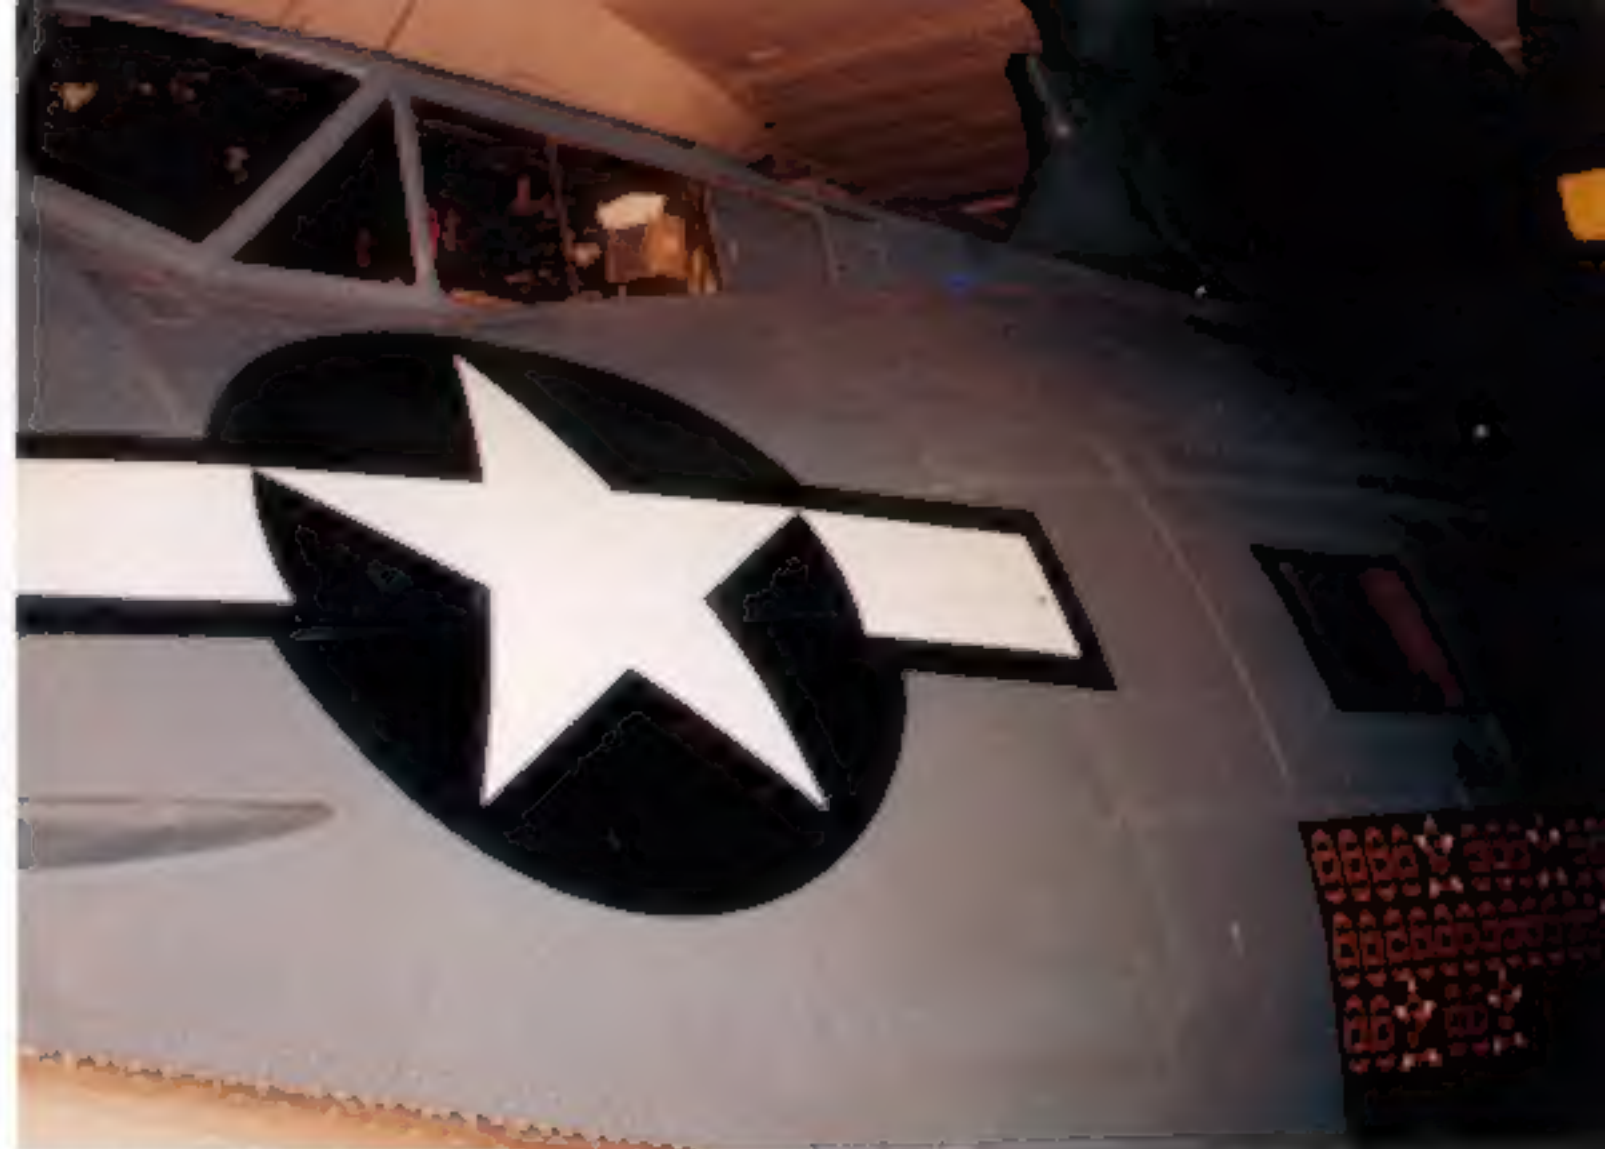
The side windows in the cockpit slid open to the rear. The instruments visible behind the pilots seat are the electrical control panel. (B. Ryle)

The knob visible on the side window is the handle for moving the sliding window. There are windshield wipers on both sides of the windscreen. (Mike Aldrich)

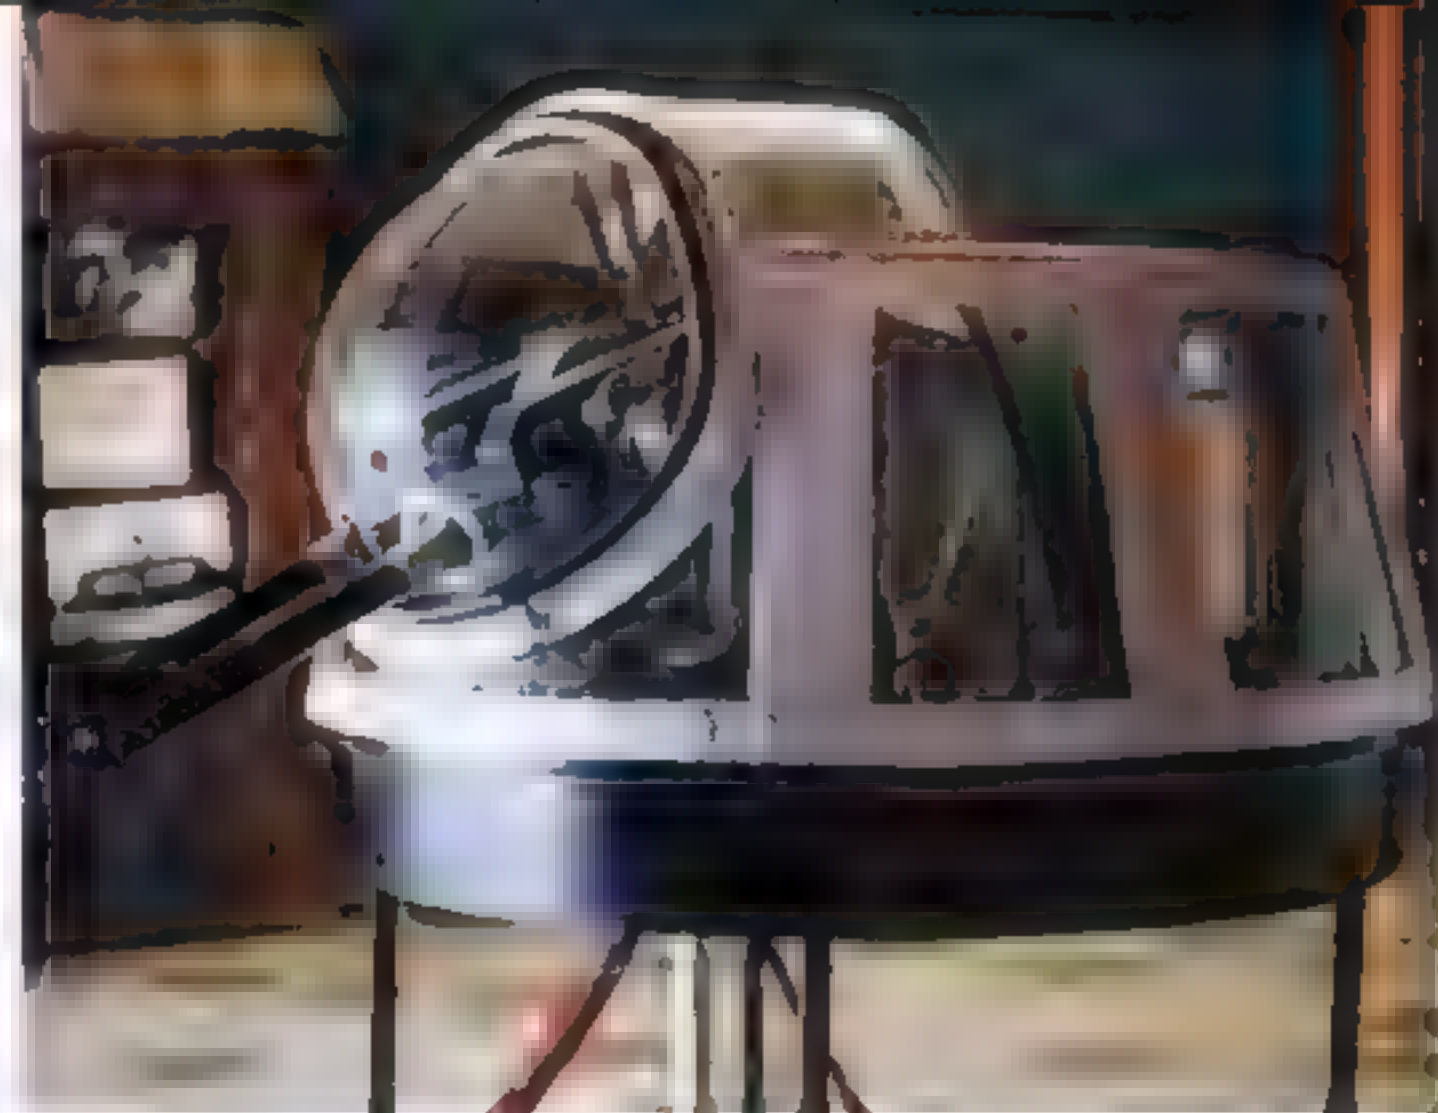
This "eyeball" 30 caliber machine gun turret was removed from a PBY and placed on display. The "eyeball" turret had two additional Plexiglas sections, the gun mount sphere and the clear upper dome cover. This mount was a modification of the earlier bow turret and retained the lower turret portion with its multiple windows. This turret was carried by all late production PBY variants and was retrofitted to many earlier aircraft as they went through rework. (Mark Aldrich)

The Plexiglas sphere holding the twin 30 caliber machine gun mount swiveled in elevation with the guns as a single unit, like an "eyeball" within a socket. The gunner stood within the bow compartment with his head inside the Plexiglas dome behind the guns. There were two large ammunition cans mounted just below the gun, bolted to the turret ring which rotated with the turret. (Mike Bobe)

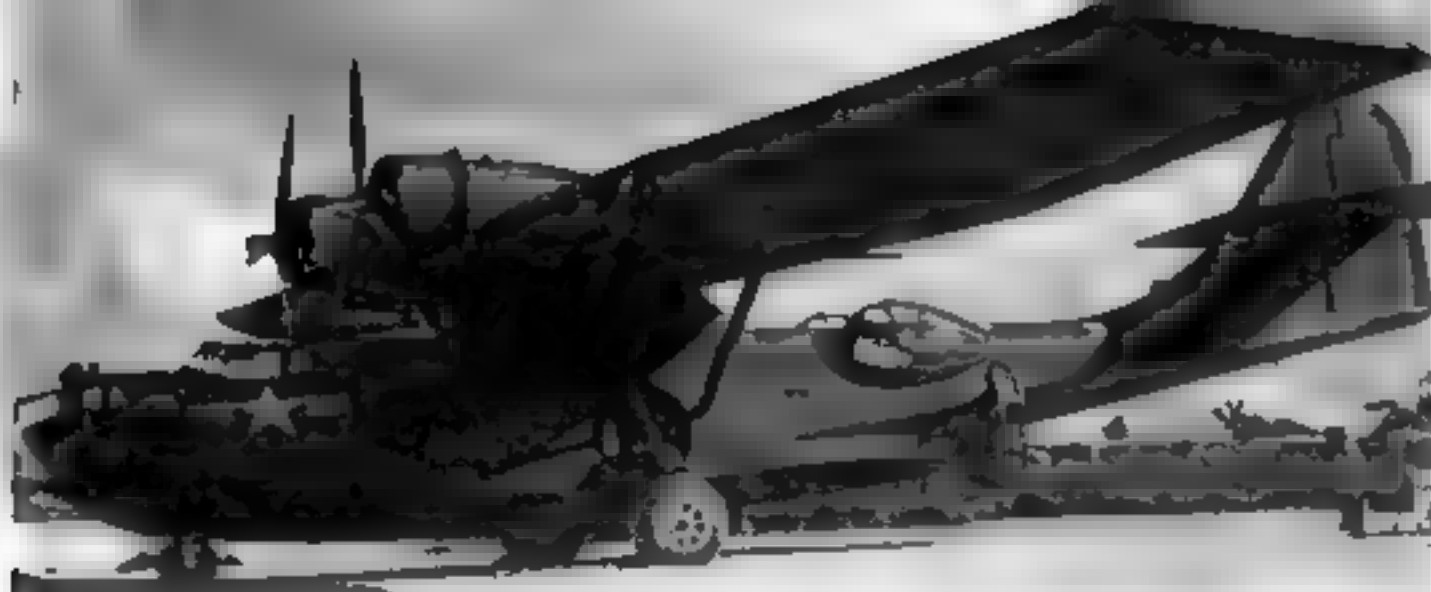
This PB4Y-2A, stationed on Guam during August of 1945, was equipped with the tunnel gun blister mount, which is visible just to the rear of the waist positions and forward of the tail. (via Mark Aldrich)

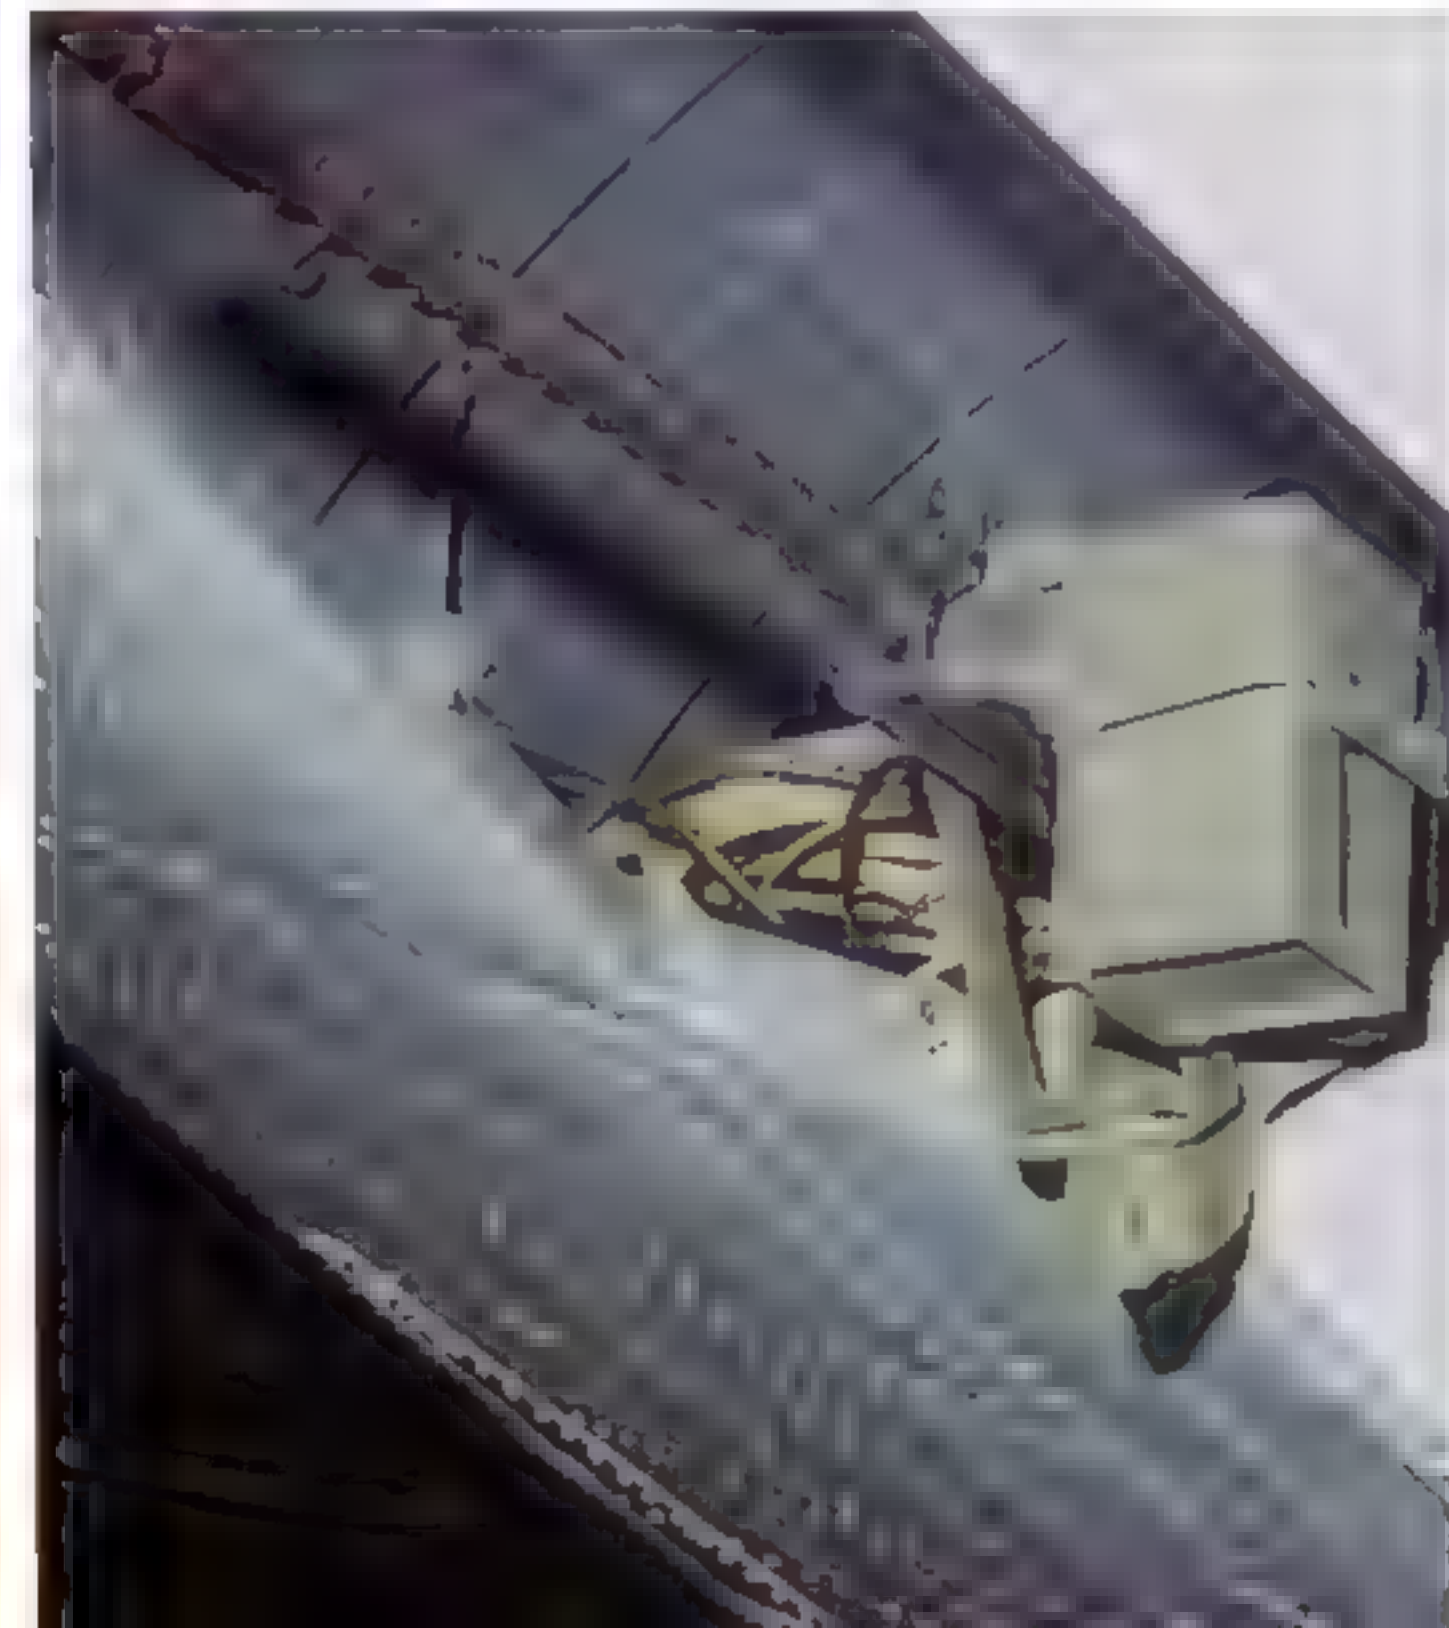
The tunnel hatch on the USAF Museum's OA-10A (serial 44-33879) is displayed in the open position with the .30 caliber Browning machine gun in the firing position. (B. Ryle)

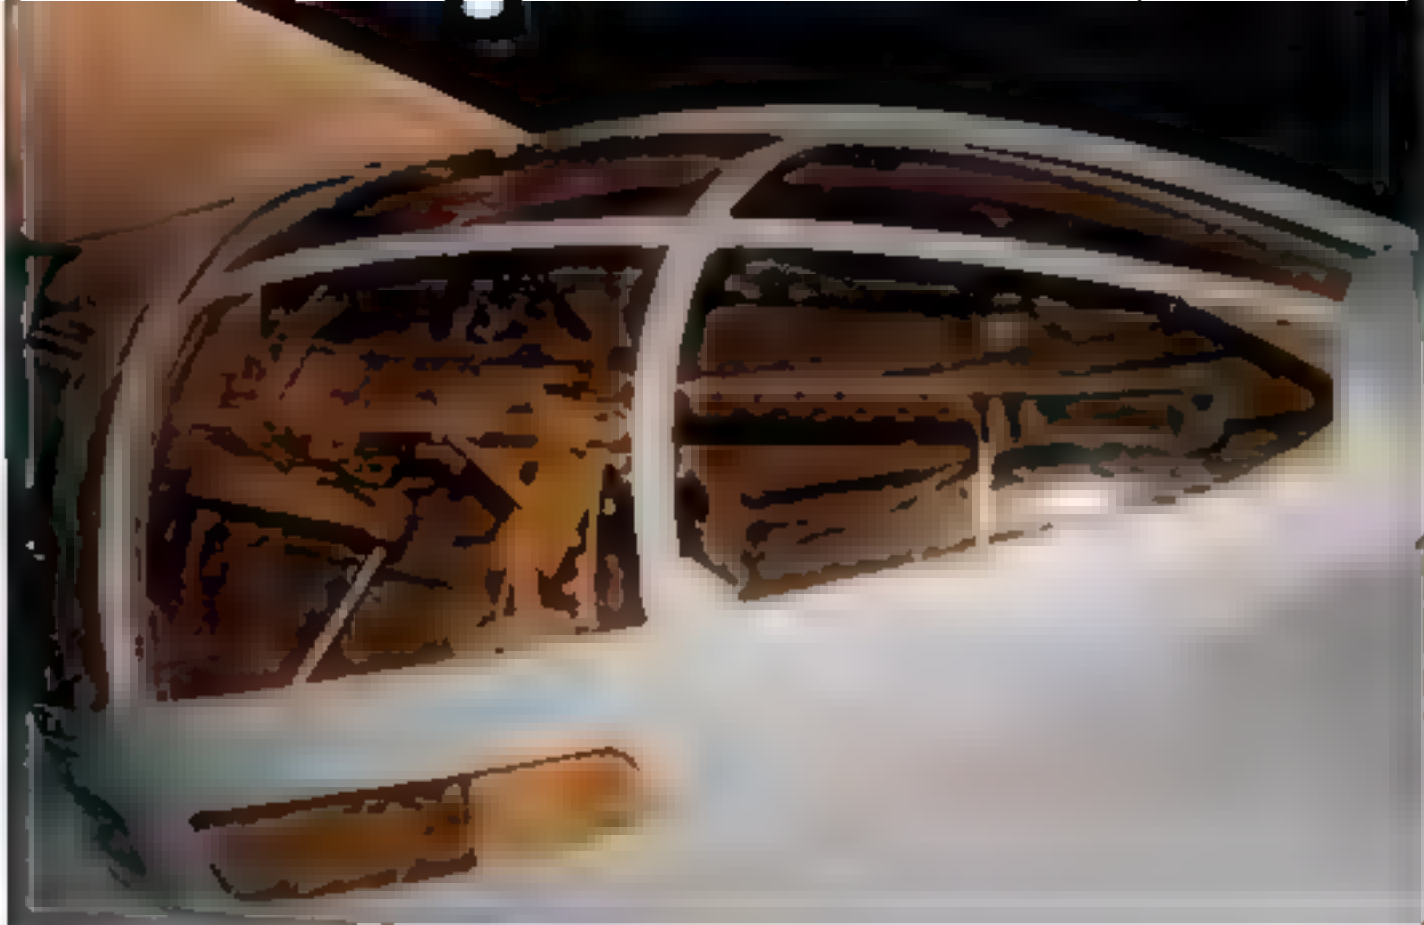
The port waist gun position with the blister in the closed position and the gun stowed. When not in a combat zone the waist position was normally kept closed since the open hatch created a considerable amount of drag. (B. Ryle)

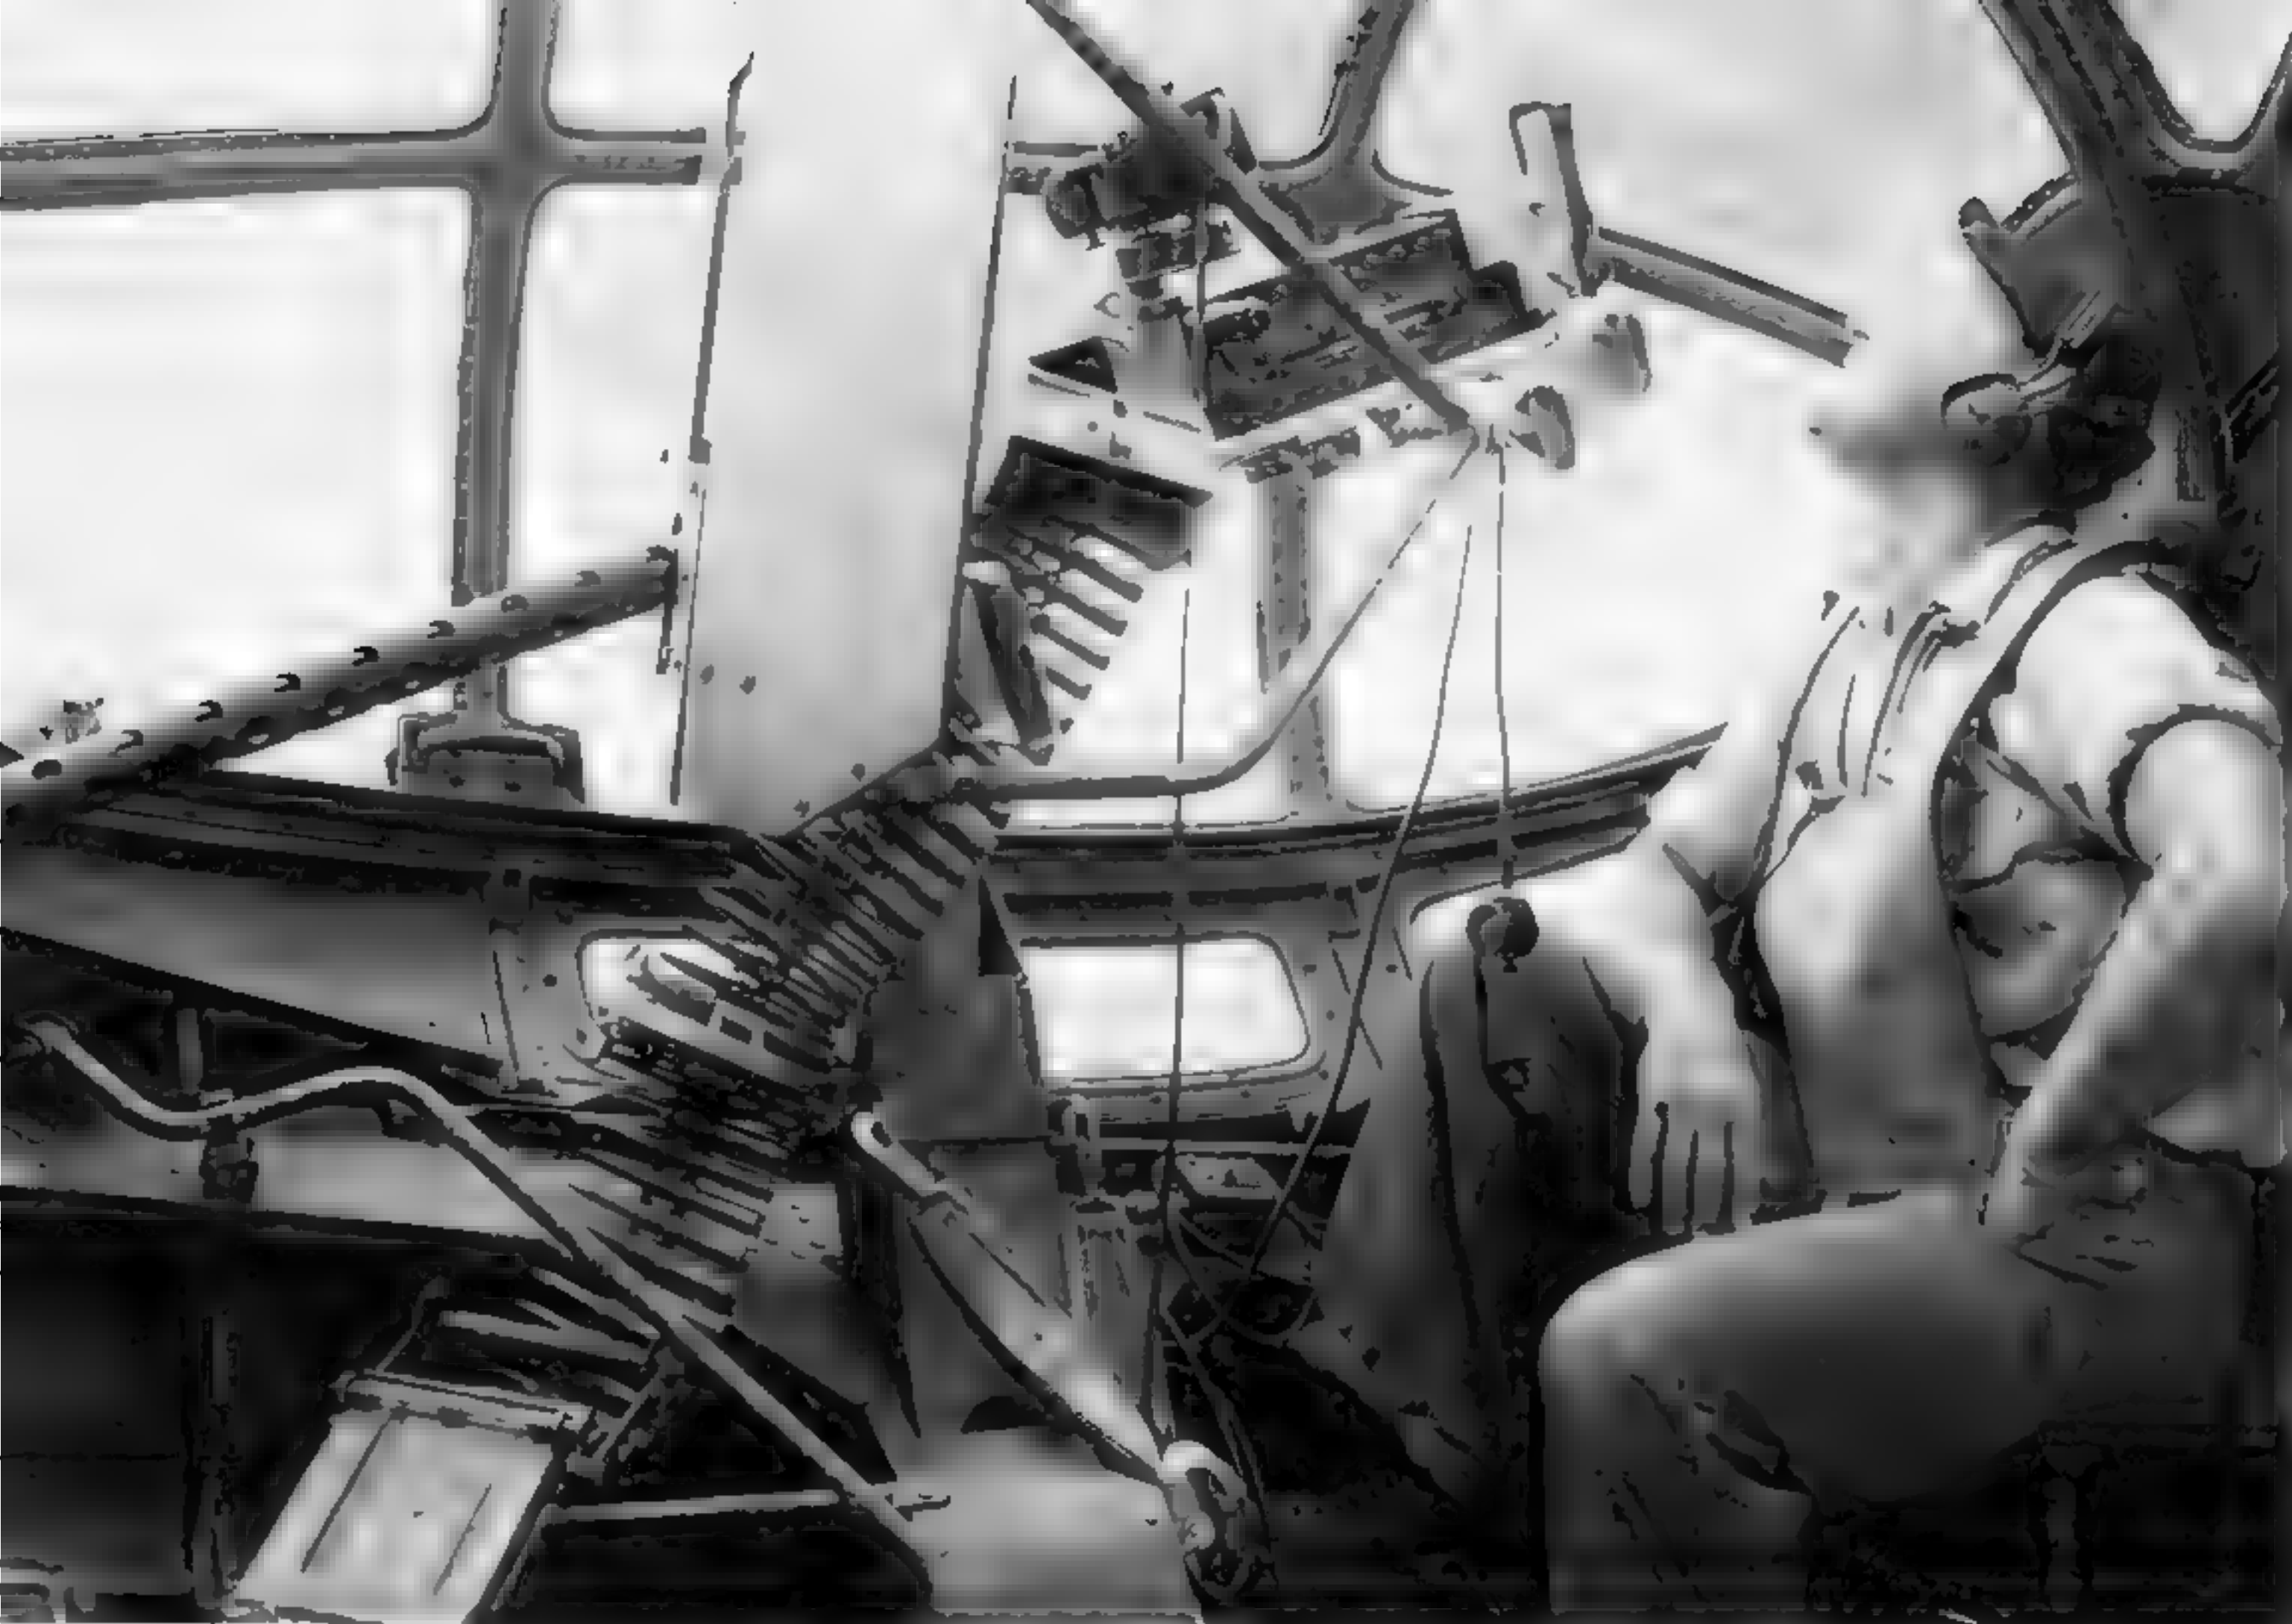
The port waist blister gunner of a VP-81 PBV-5, based on Bougainville, in the Solomons Island Chain, keeps watch while on patrol during January of 1944. The Browning 50 caliber machine gun was equipped with an armor shield, Mk 9 reflector sight and power-assist ammunition feed from a central magazine on the deck. The bent rod at the lower left is a protective device that kept the gunner from firing into the tail of the aircraft when the blister was open (USN via National Archives)

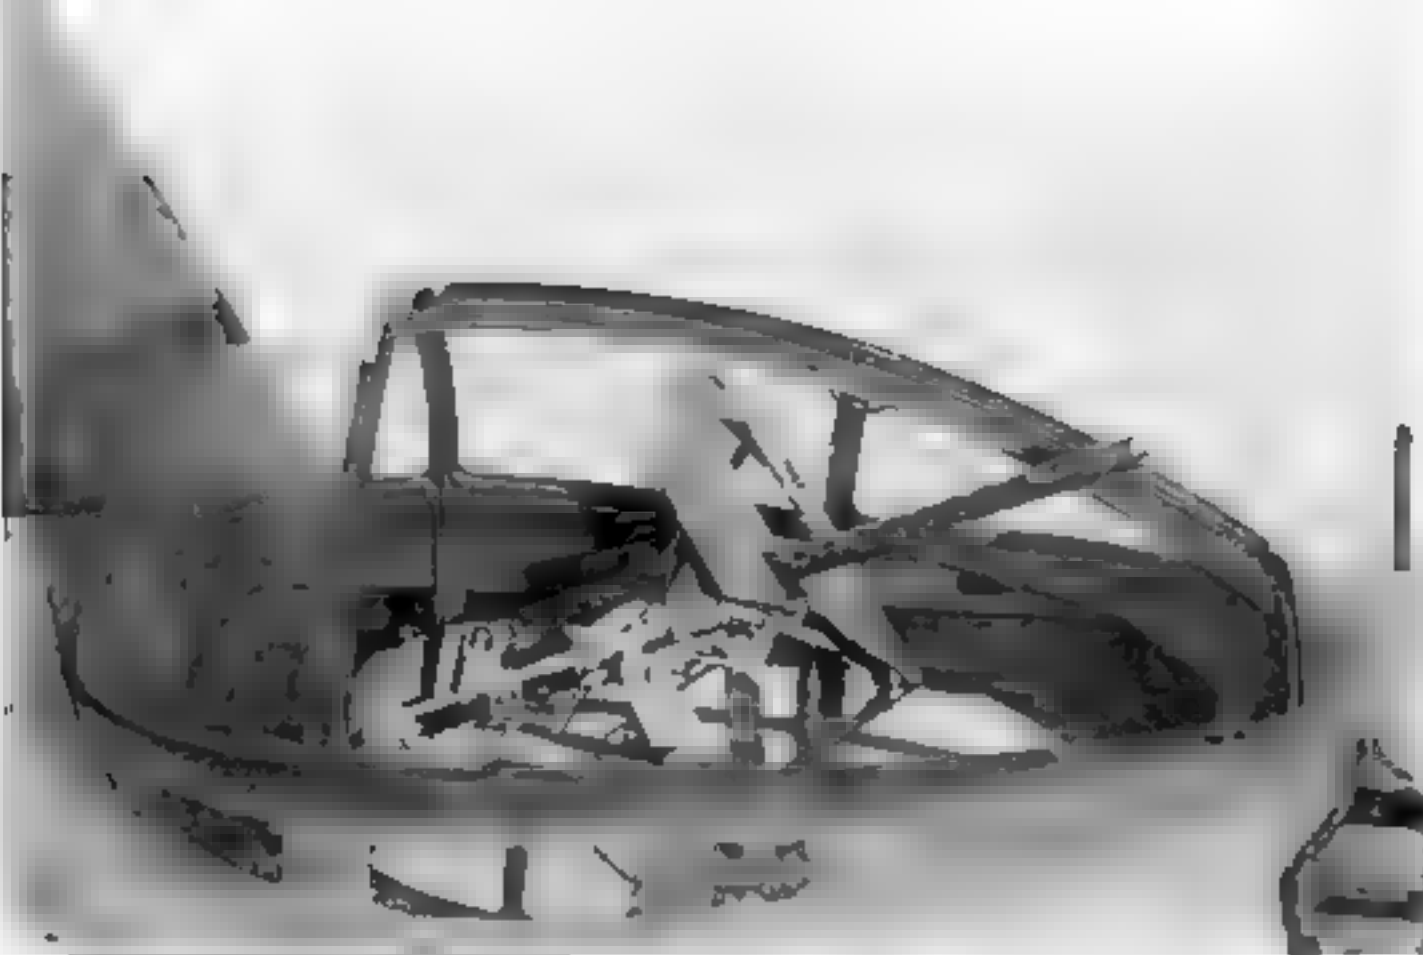
The port waist gun position on PBV-5A (BuNo 48262) with the gun in the firing position and the blister window open. (USN)

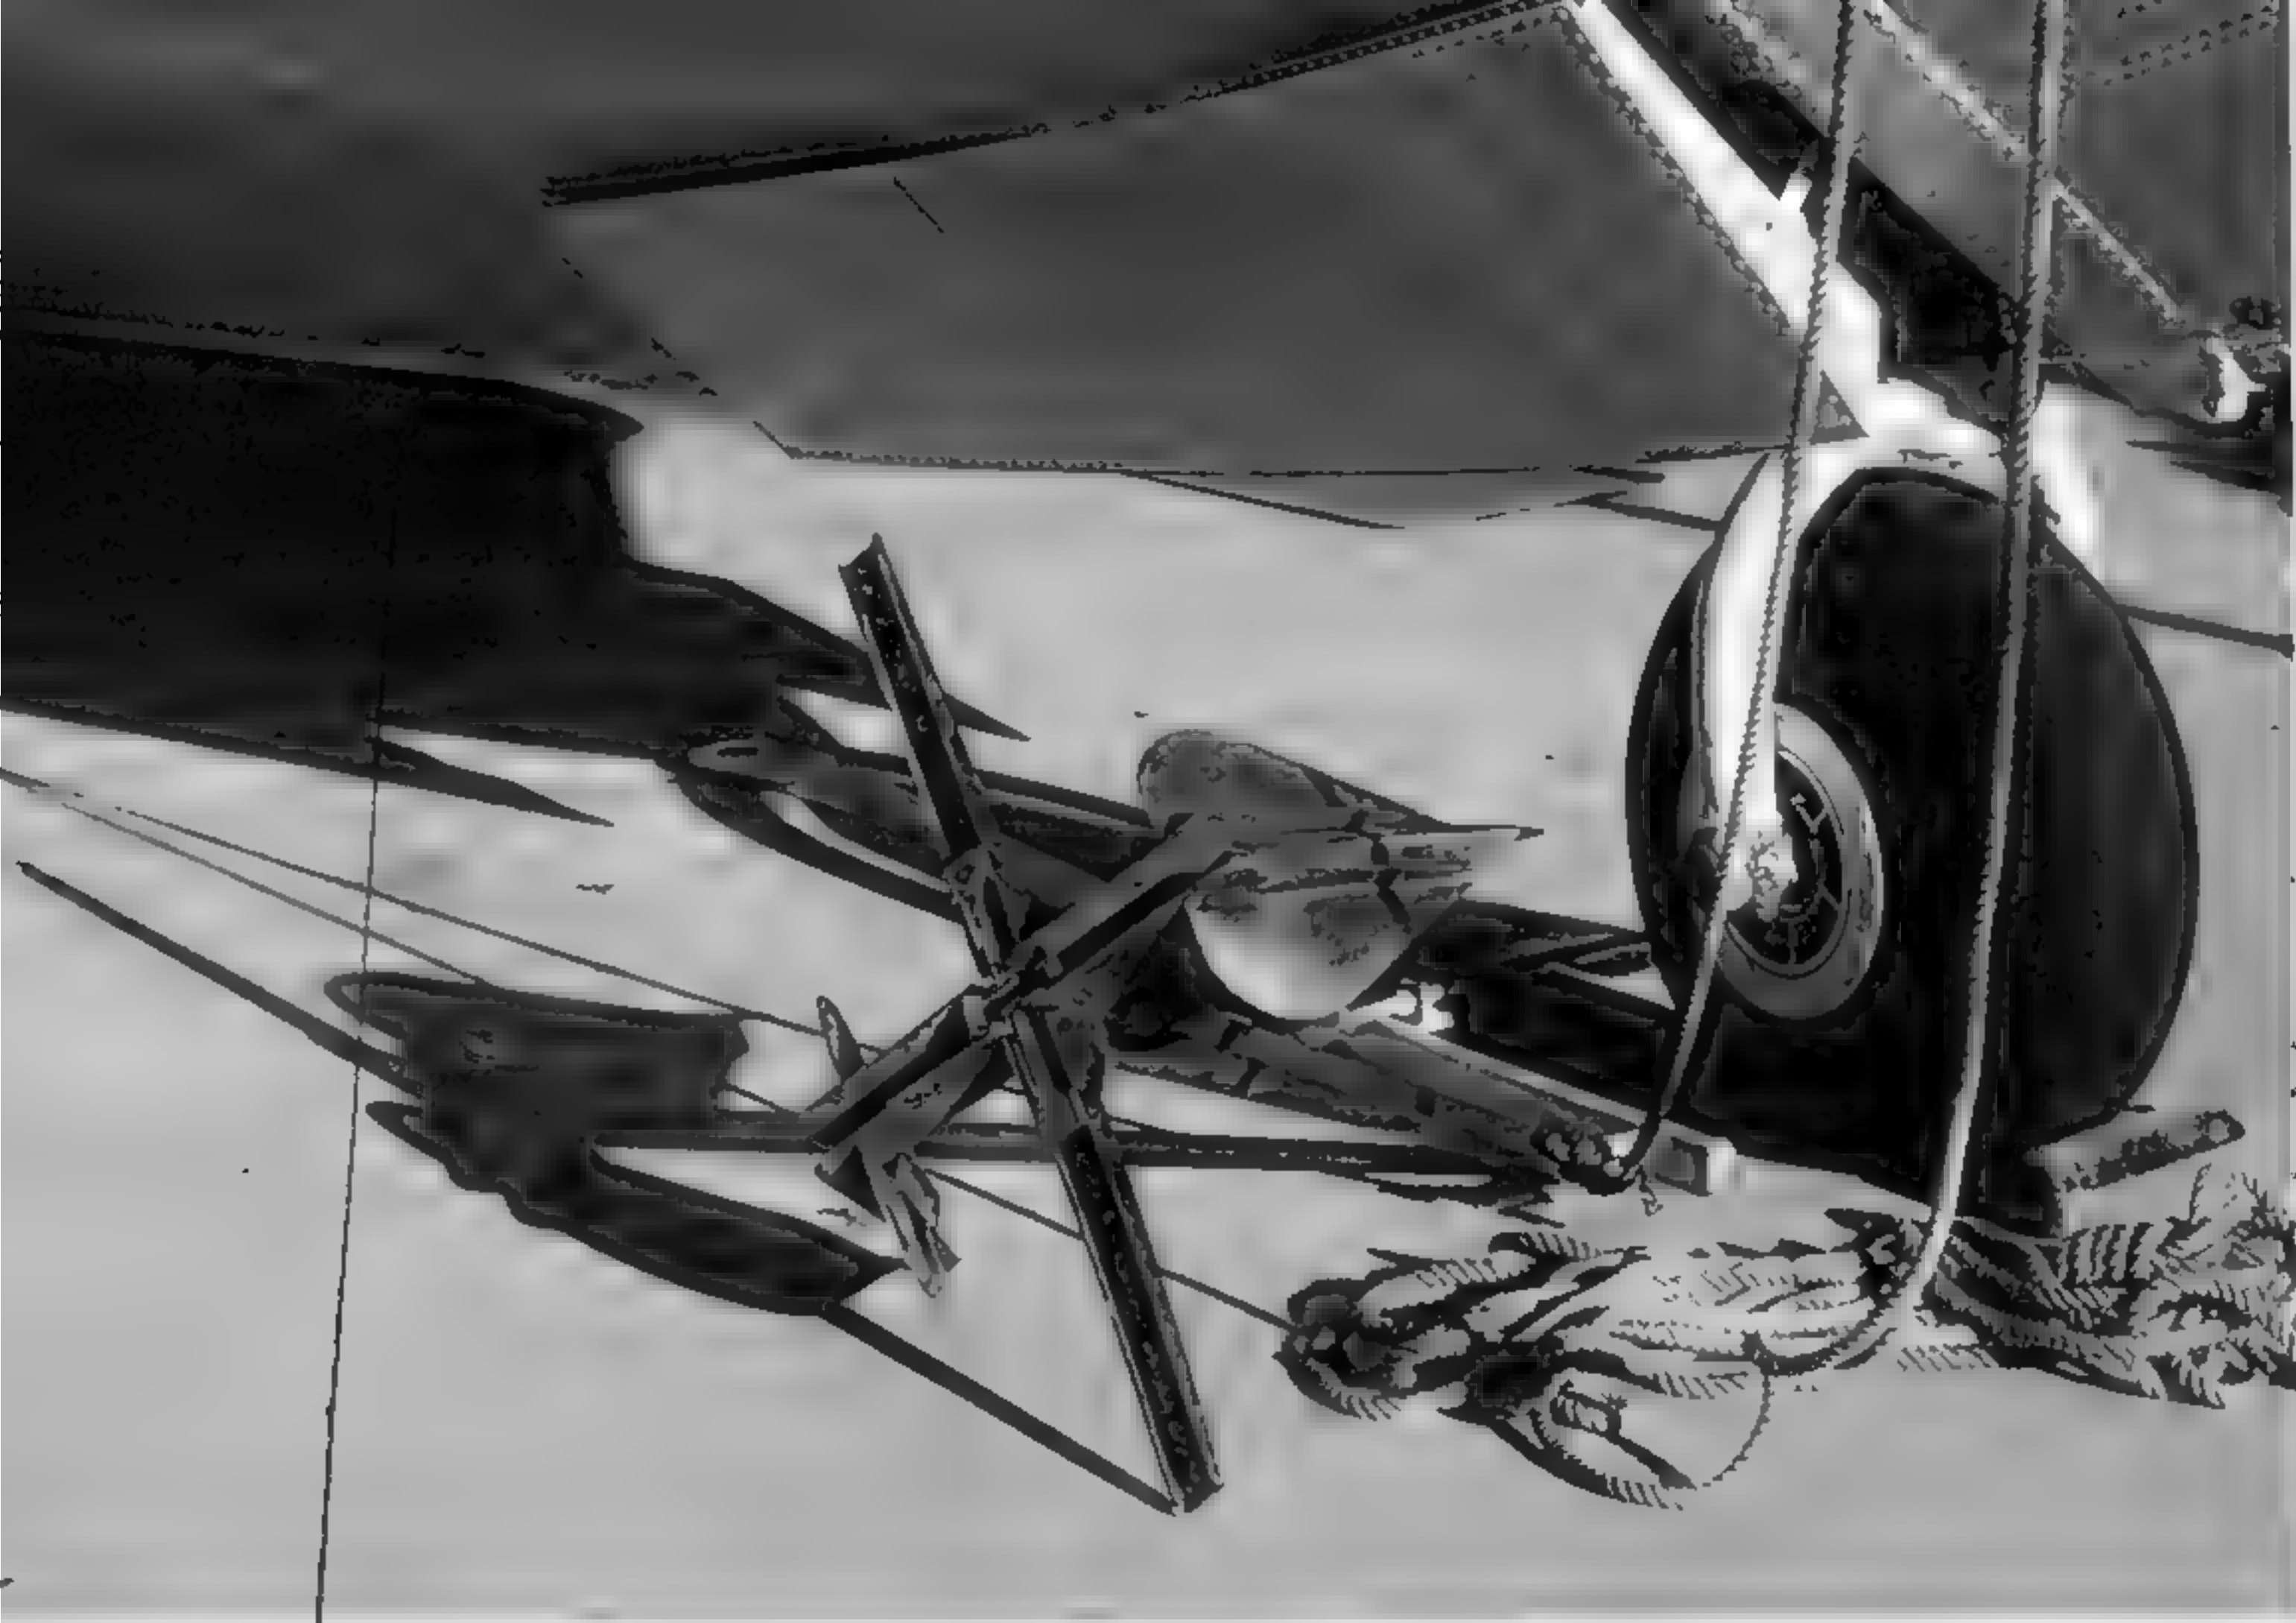
This is the nose wheel, nose wheel doors anchor and anchor line of the Confederate Air Force PB-5A. The anchor is usually stored in a compartment on the port side of the nose. The fully steerable nose wheel with a smooth tire and twin fork mount. Service Cats used this type of anchor with a stainless steel wire anchor cable. (Mark Aldrich)
